Technical Report CERC-96-8
September 1996

Periodic Inspection of Burns Harbor North Breakwater, Indiana

Report 1 Base Conditions

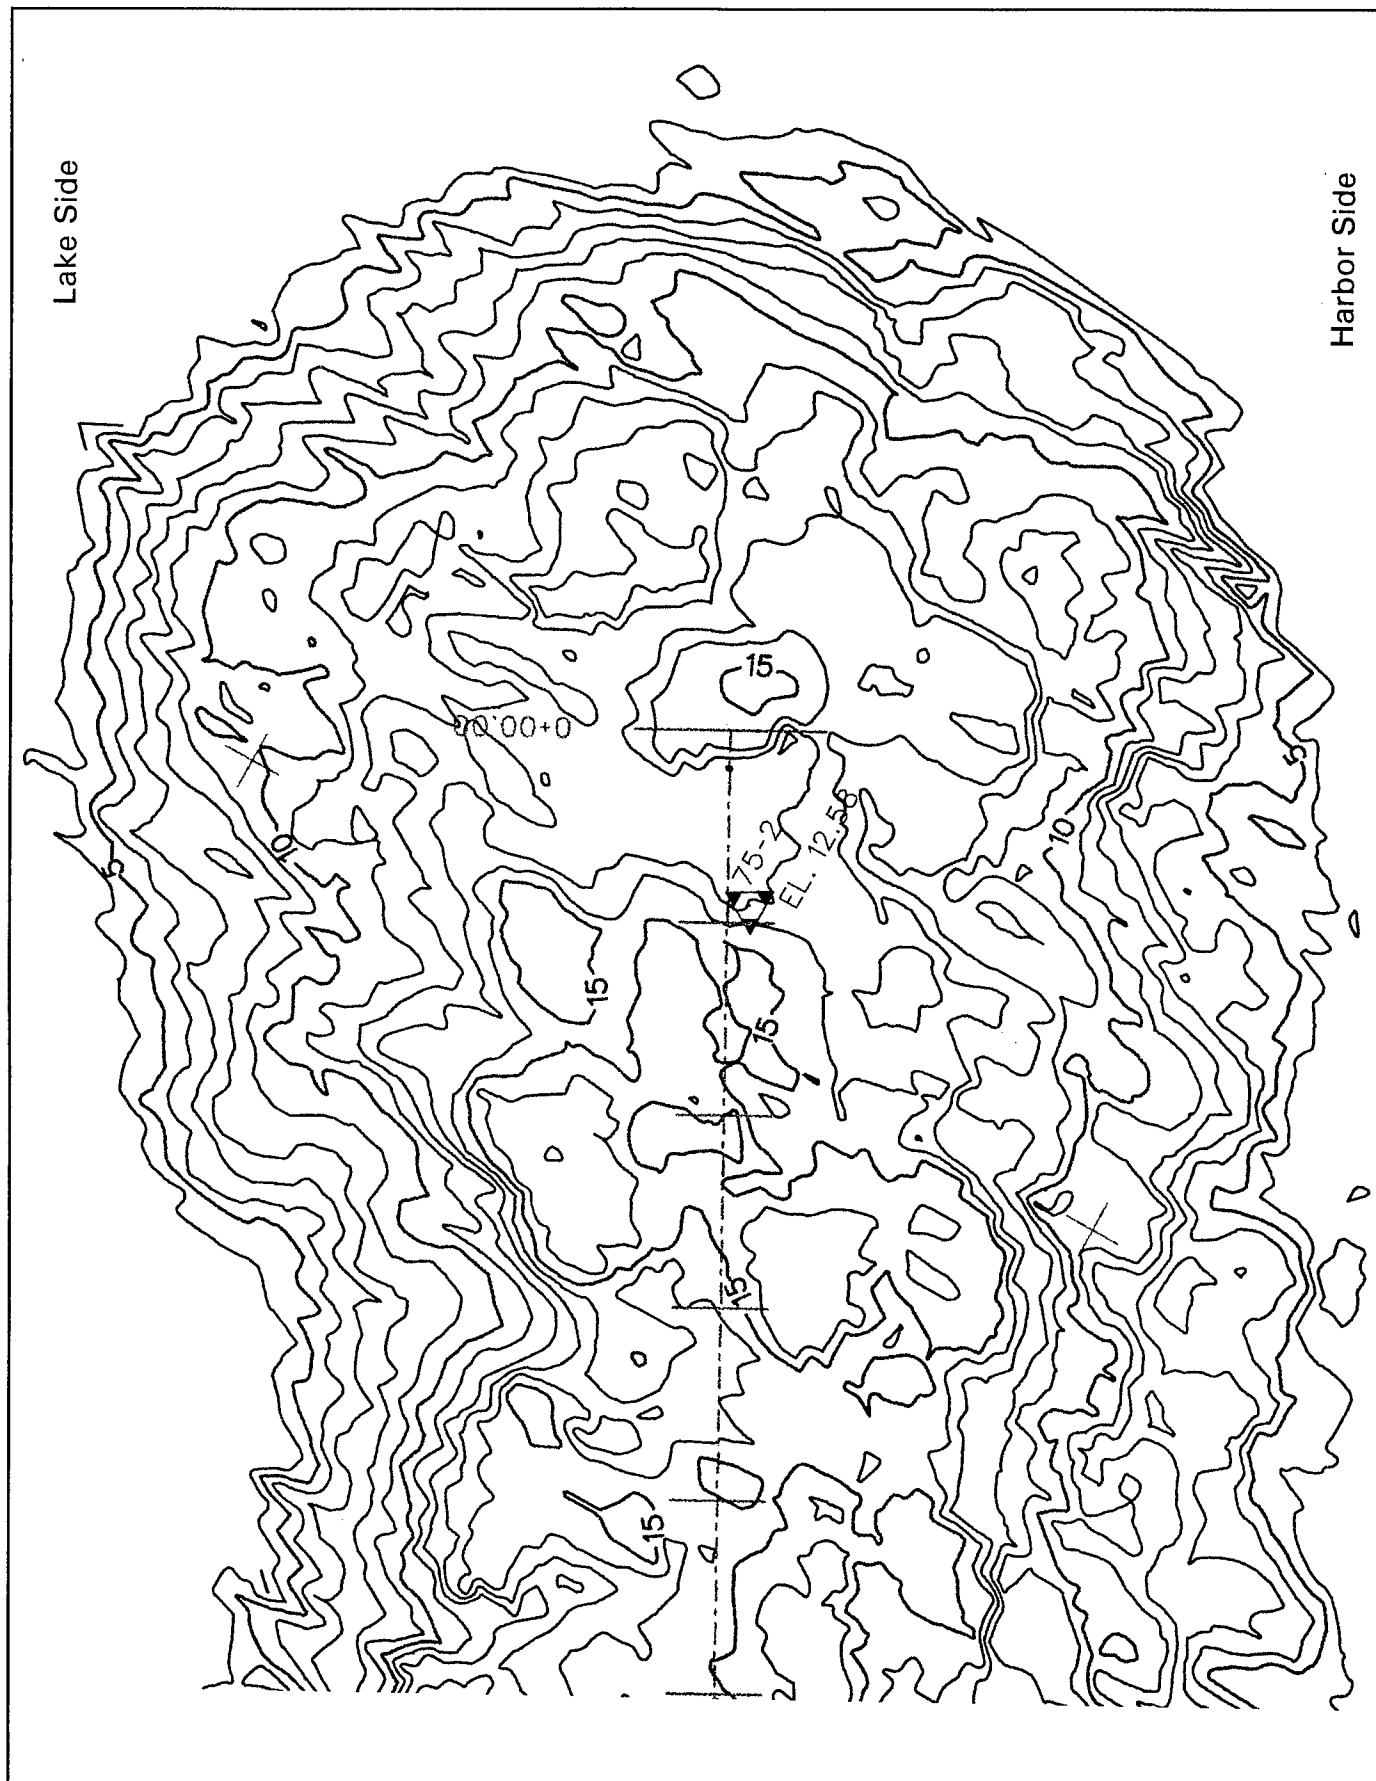
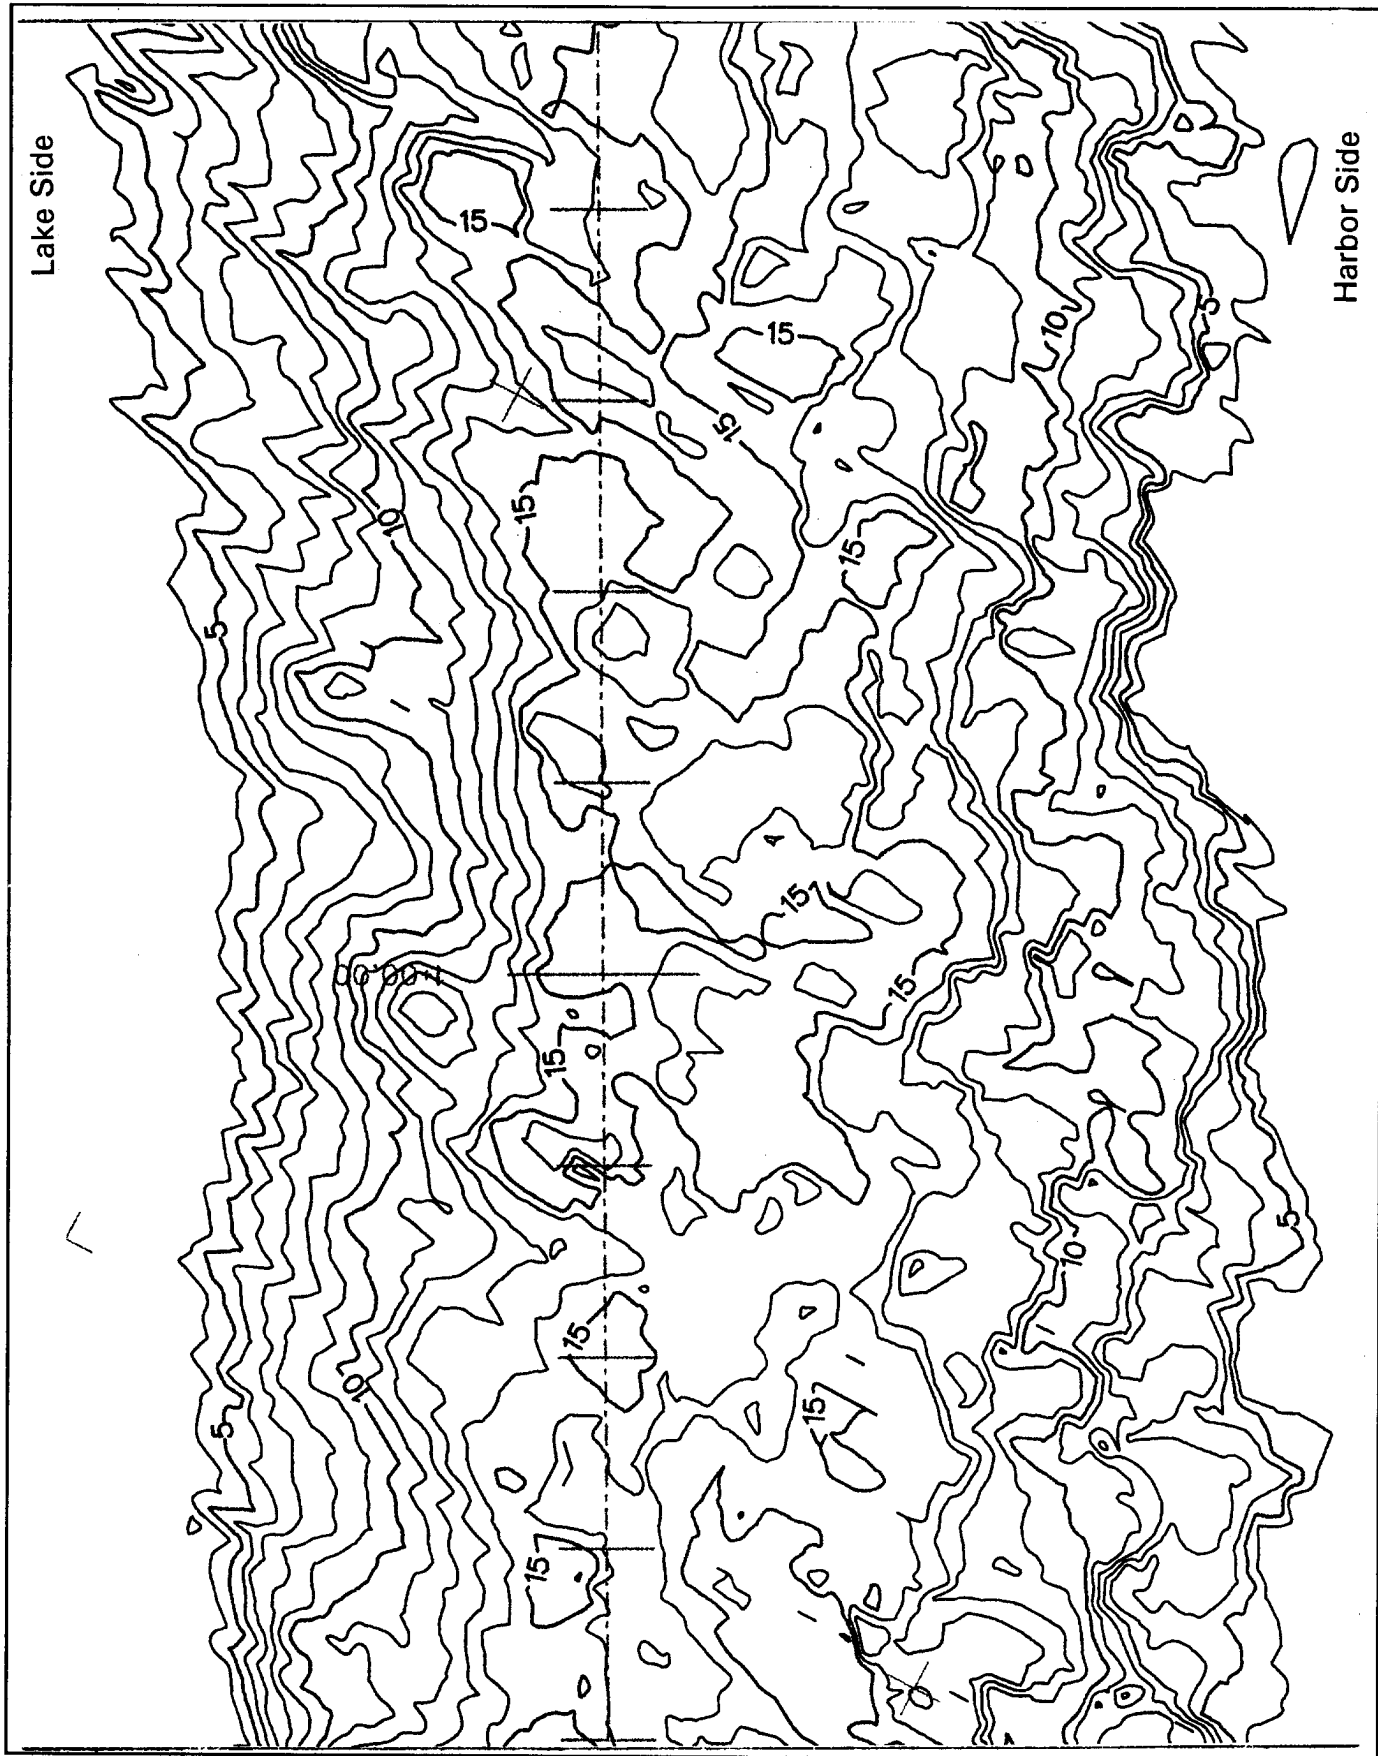
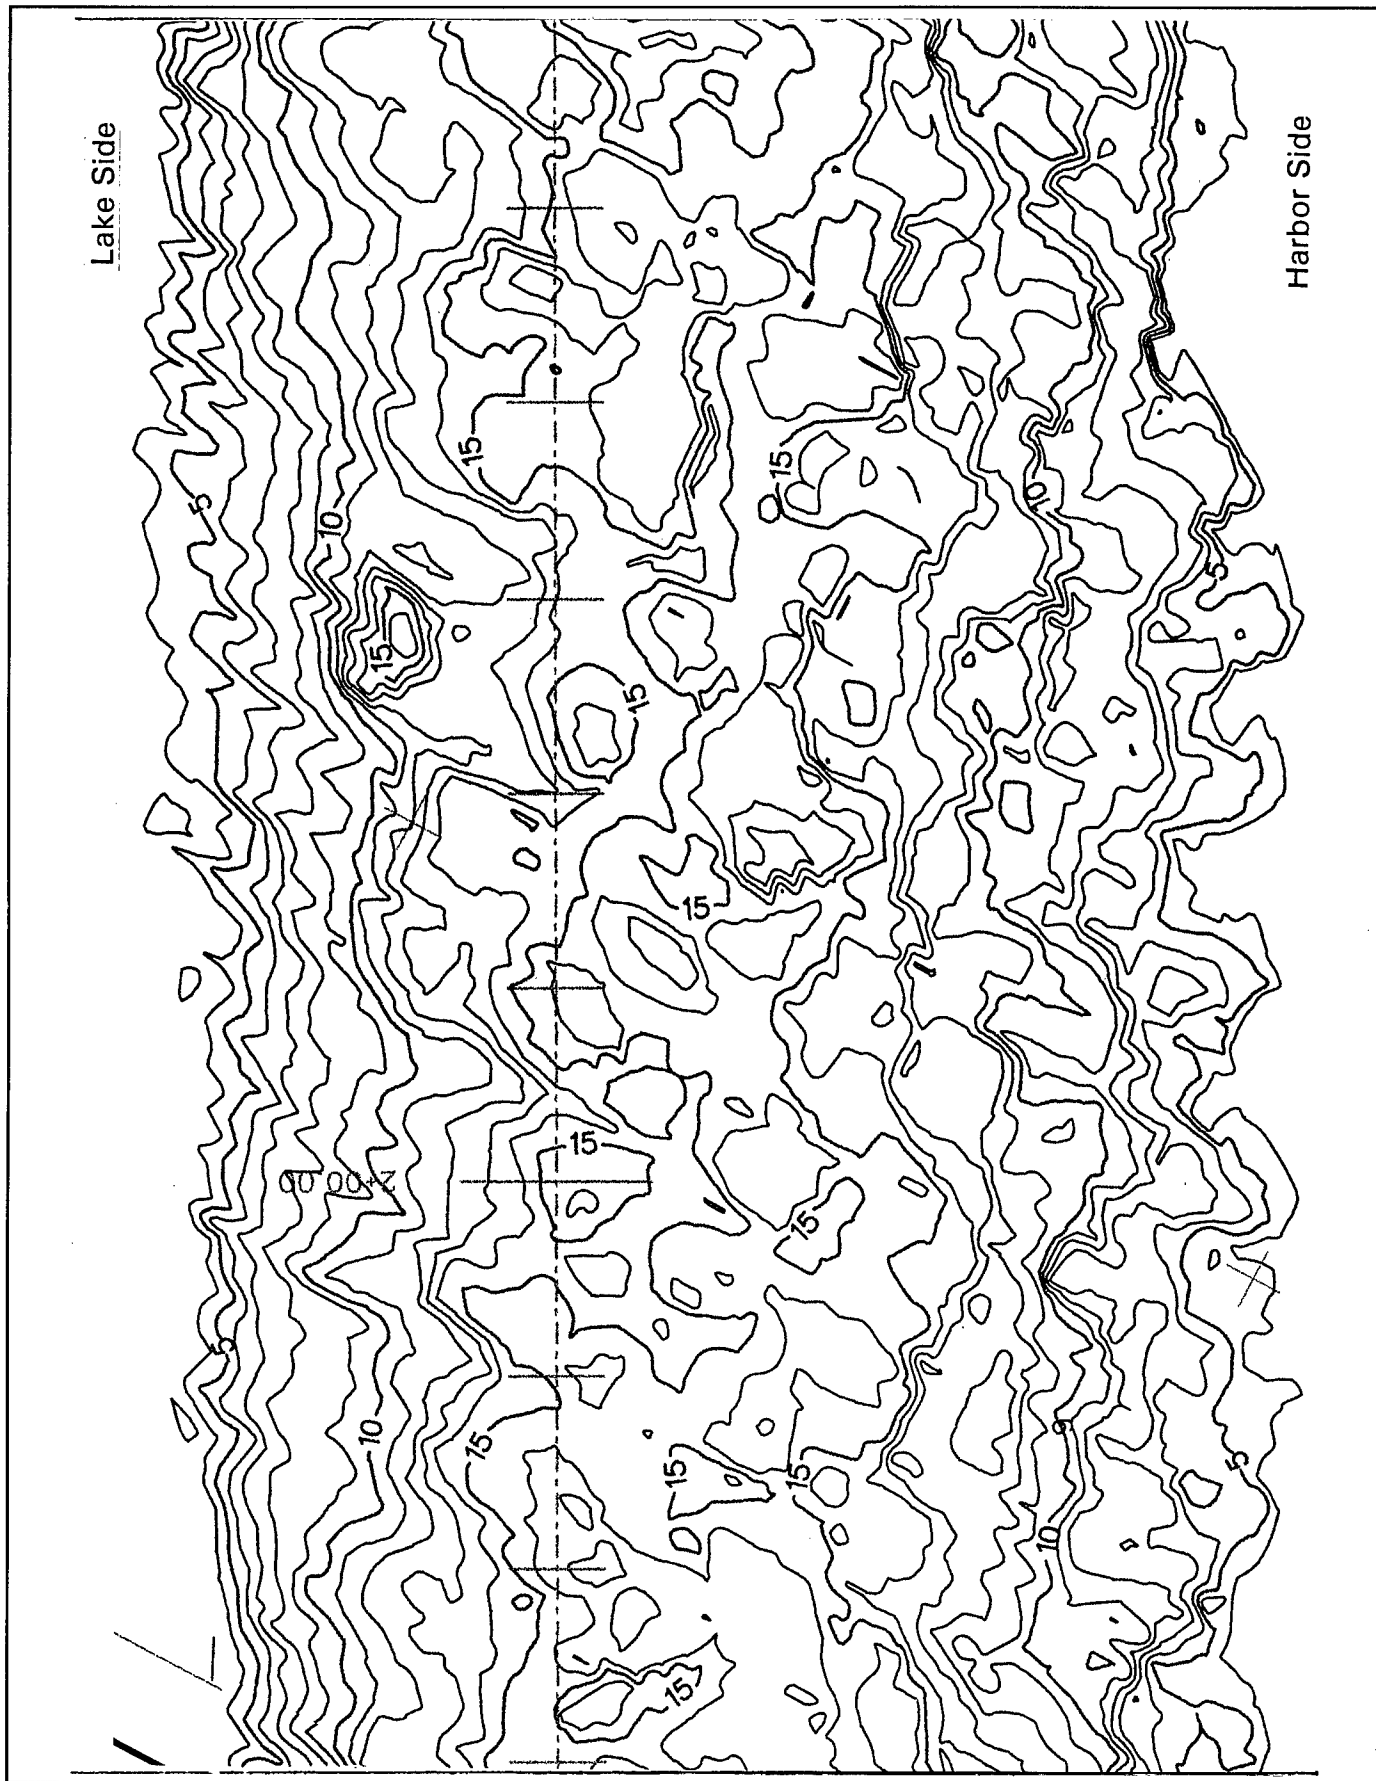
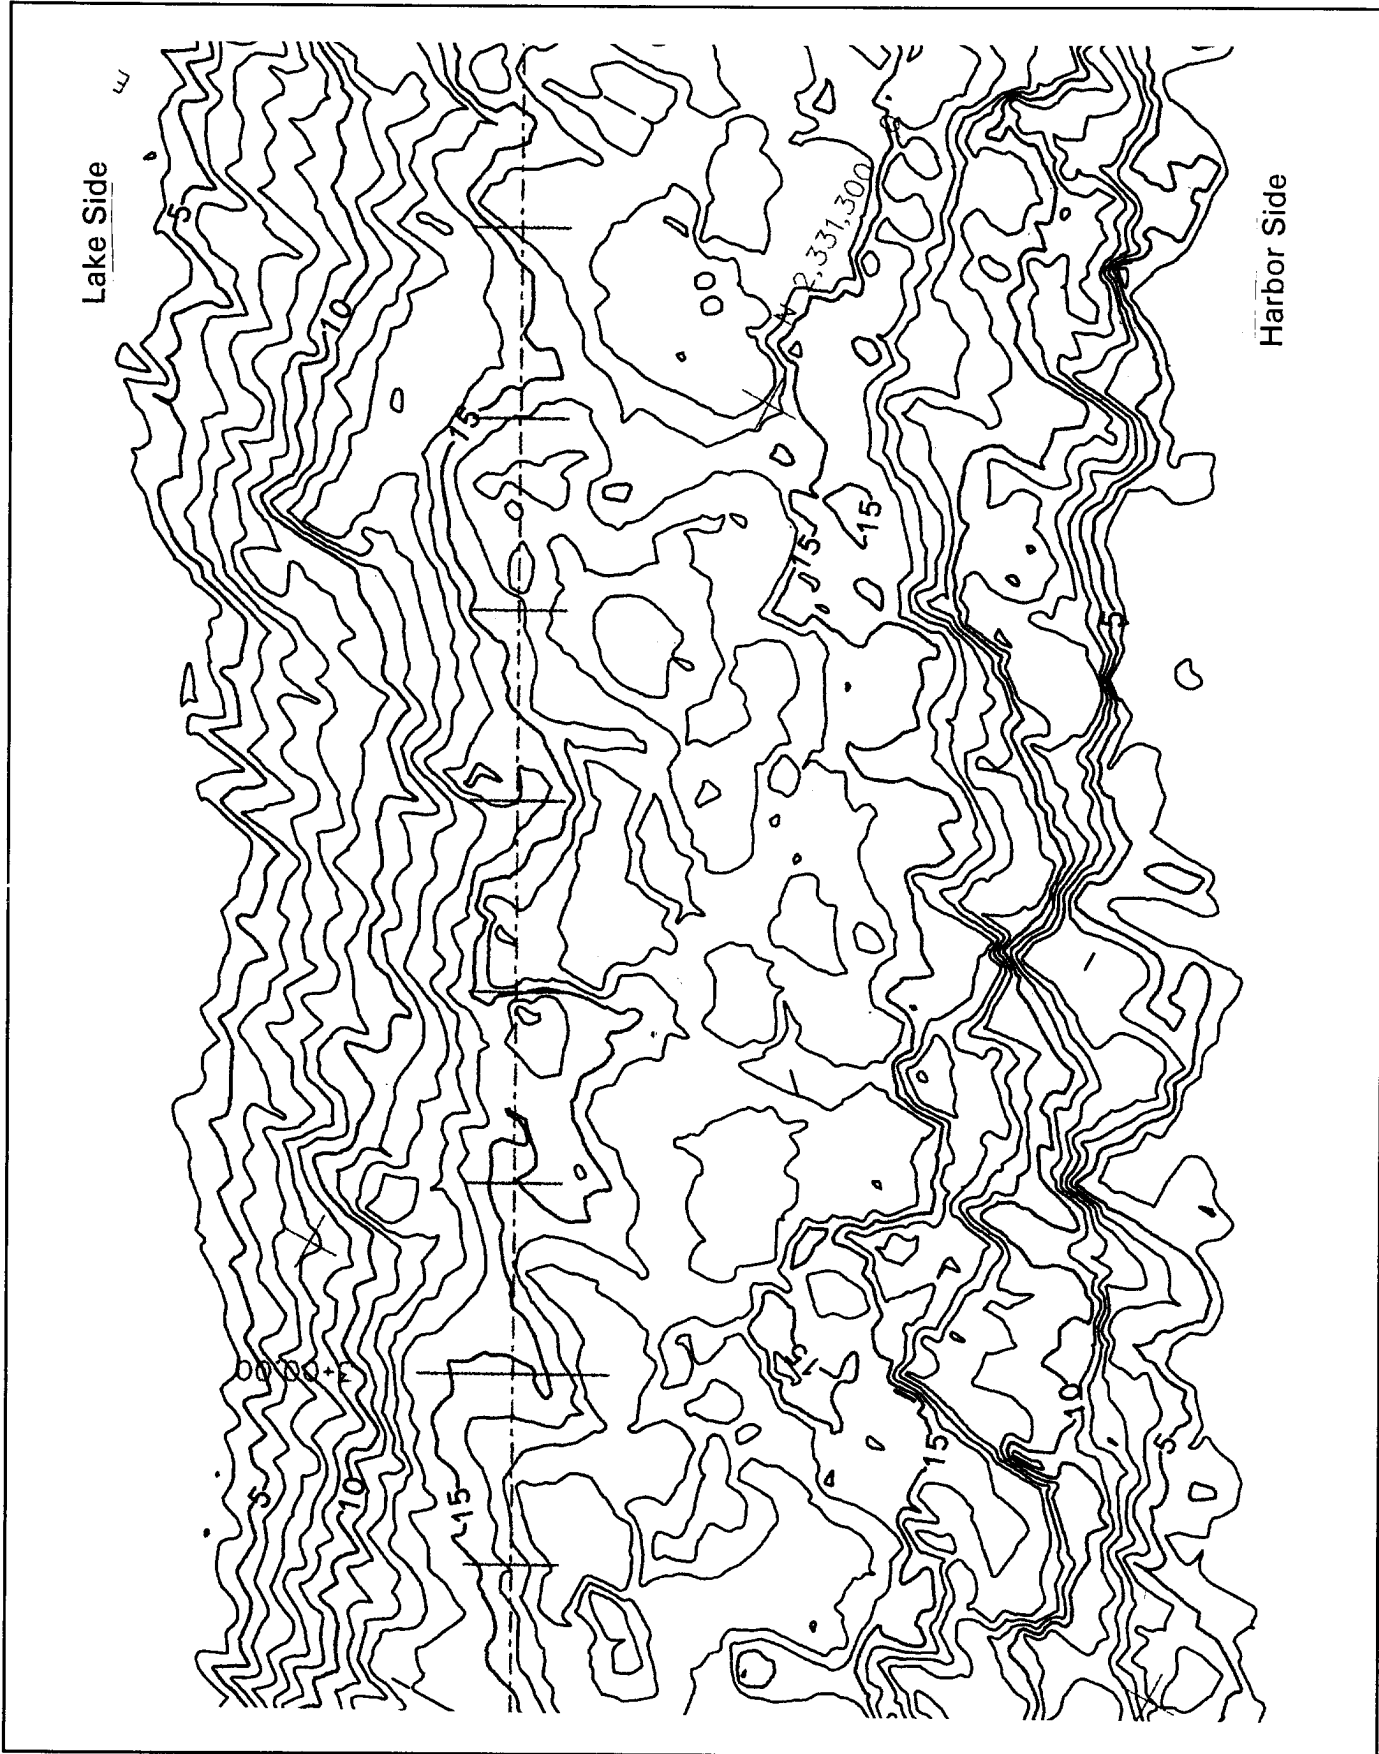
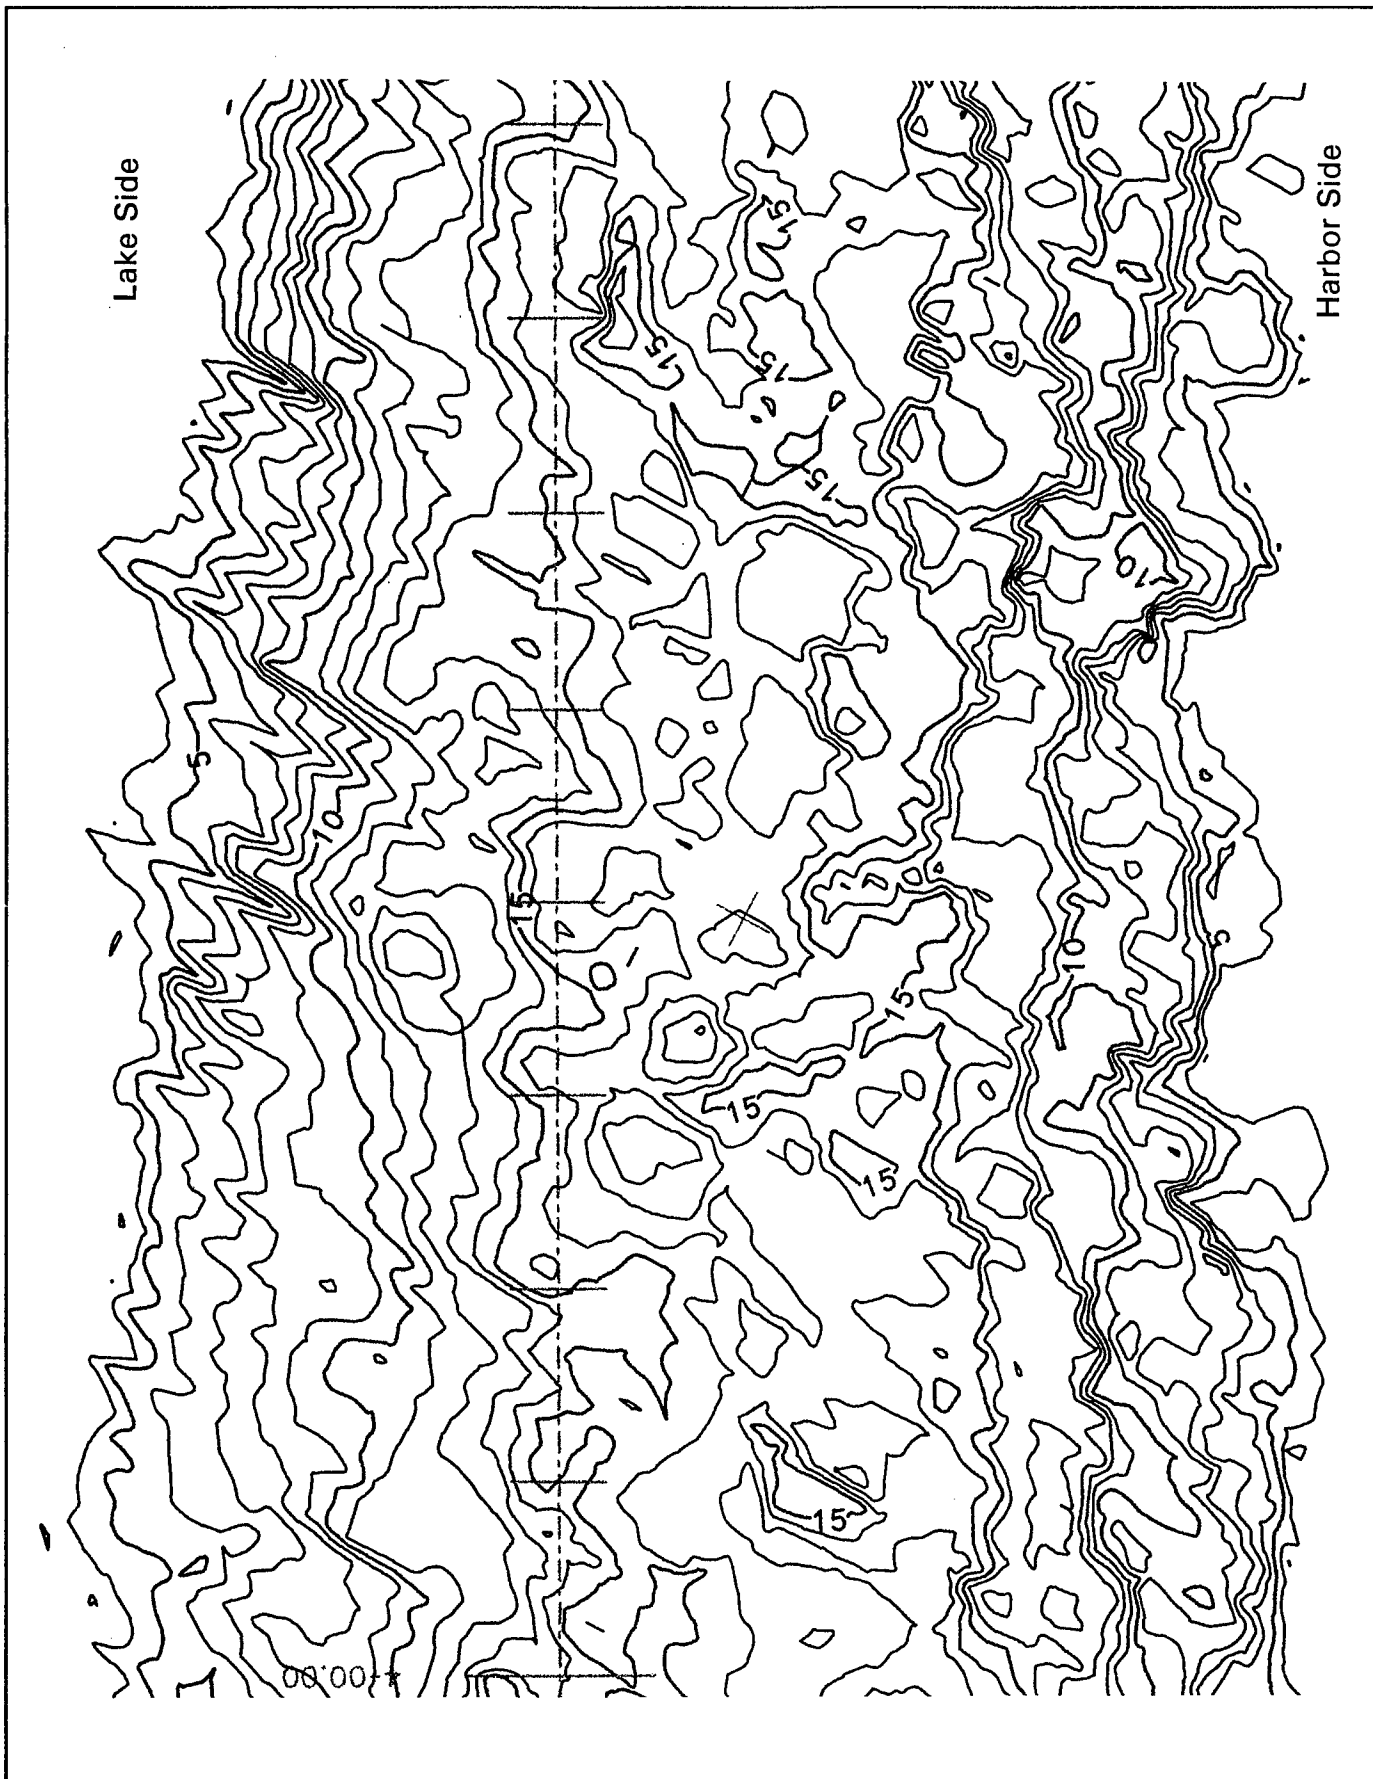
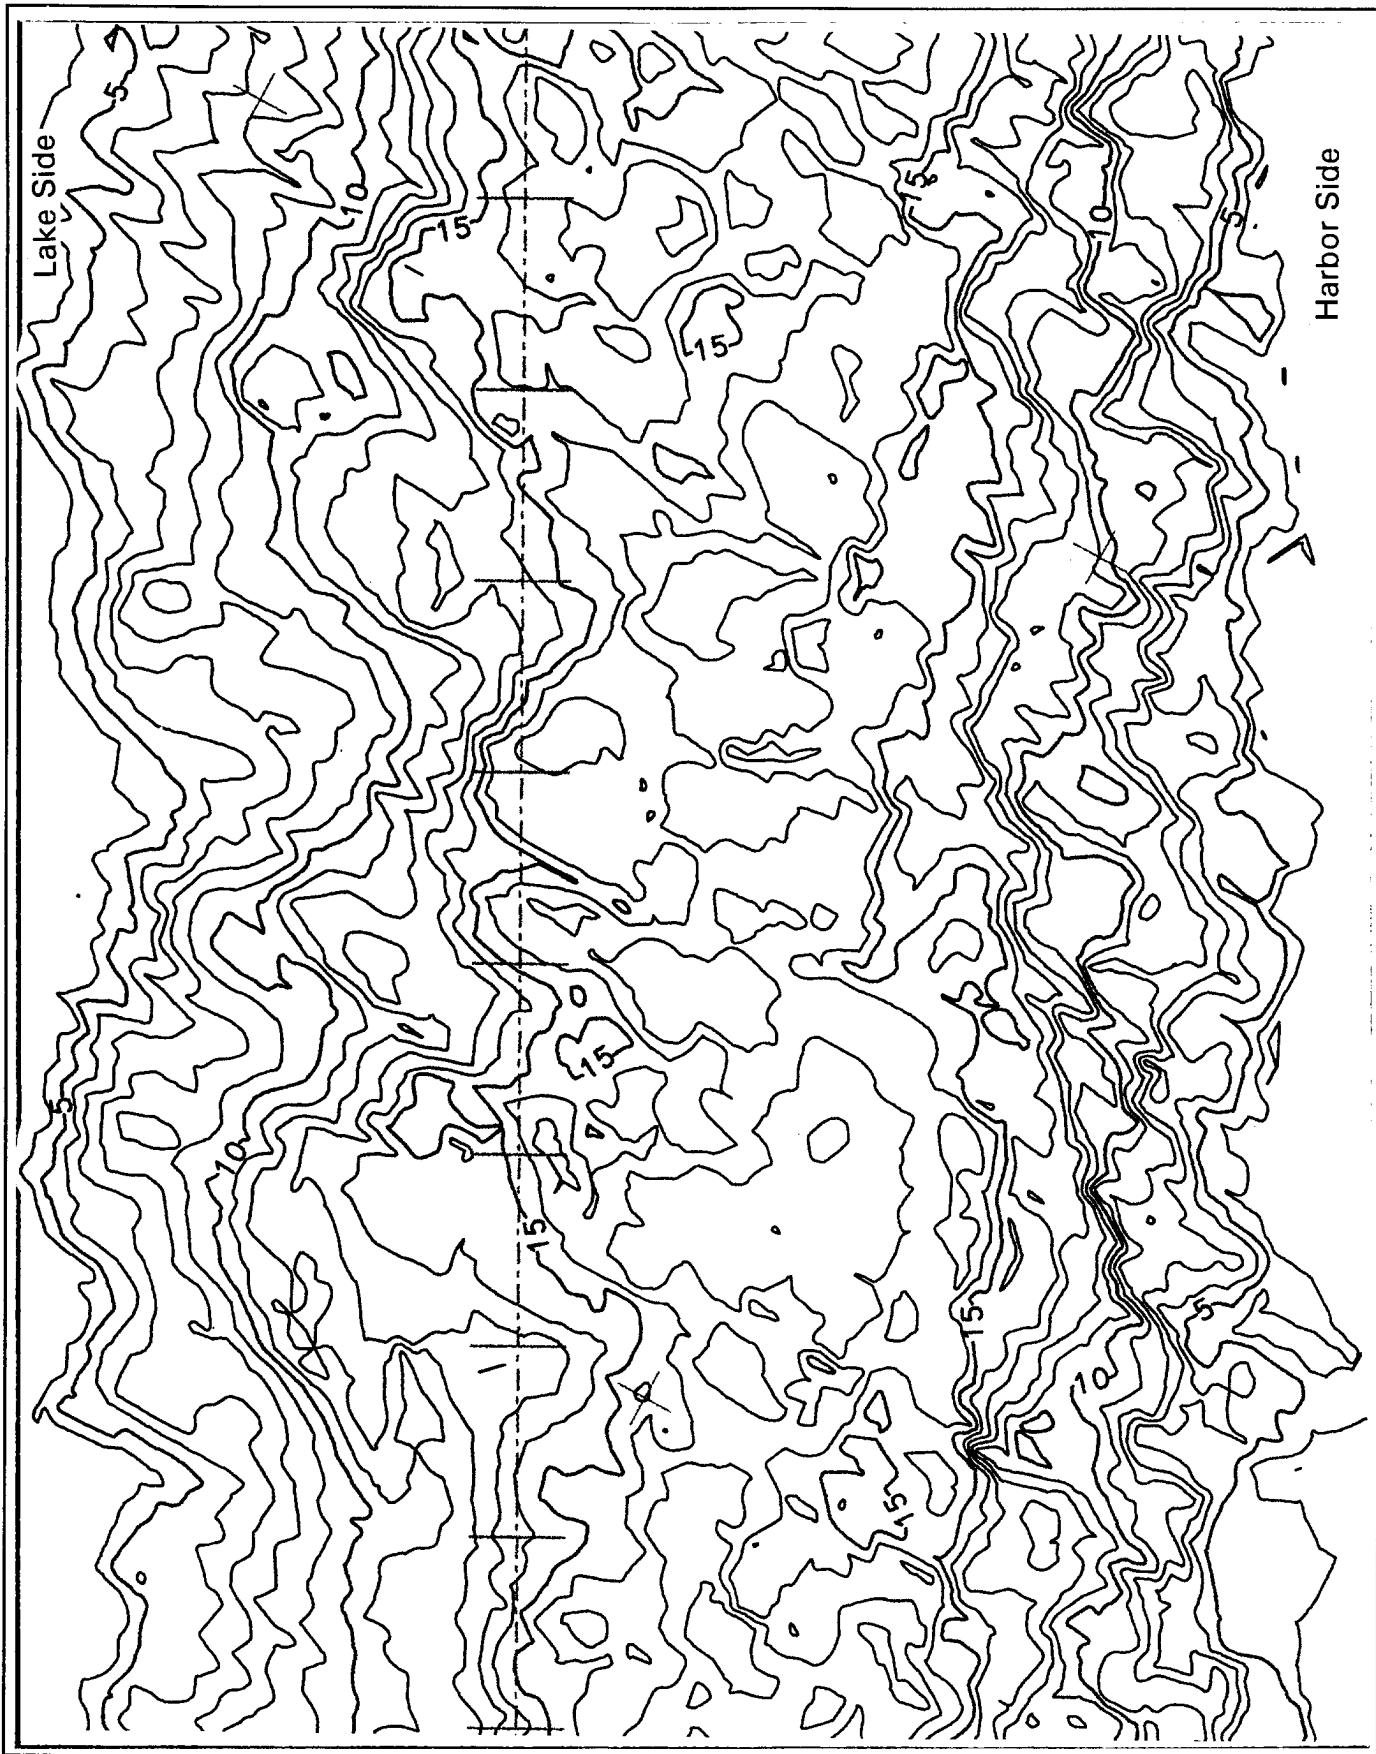
This appendix presents contour maps of the Burns Harbor North Breakwater. Topography was developed using the digital terrain model (DTM) as stated in the main text of this report. The breakwater topography is shown on a 0.3-m (1.0-ft) contour interval. Elevations shown are in feet referred to low water datum (lwd). To convert them to meters, multiply by 0.3048. Station numbering on the contour maps is from east to west (right to left). The scale of the maps is 25.4 mm = 3.05 m (1 in = 10 ft).

An examination of the breakwater topography and cross-section data (Appendixes A and B) reveals low areas along much of the breakwater. Cumulatively, about 344 linear m (1,130 linear ft), or 24 percent of the total length, of the breakwater is below the design crest el of +4.3 (+14).

Most of these low areas range in elevation from +3.7 to +4.3 (+12 to +14). Only about 66 linear m (215 linear ft) cumulative length of the breakwater (4.6 percent) is below the +3.7-m (+10-ft) elevation. Low areas in the structure appear to be concentrated between sta 12+20-15+00 and sta 30+80-37+50. These data also reveal that the design crest width of 5.2 m (17 ft) is not maintained in many areas. In addition, on some portions of the structure, the slope on the harbor side of the breakwater is steeper than the original 1V:1.5H design.

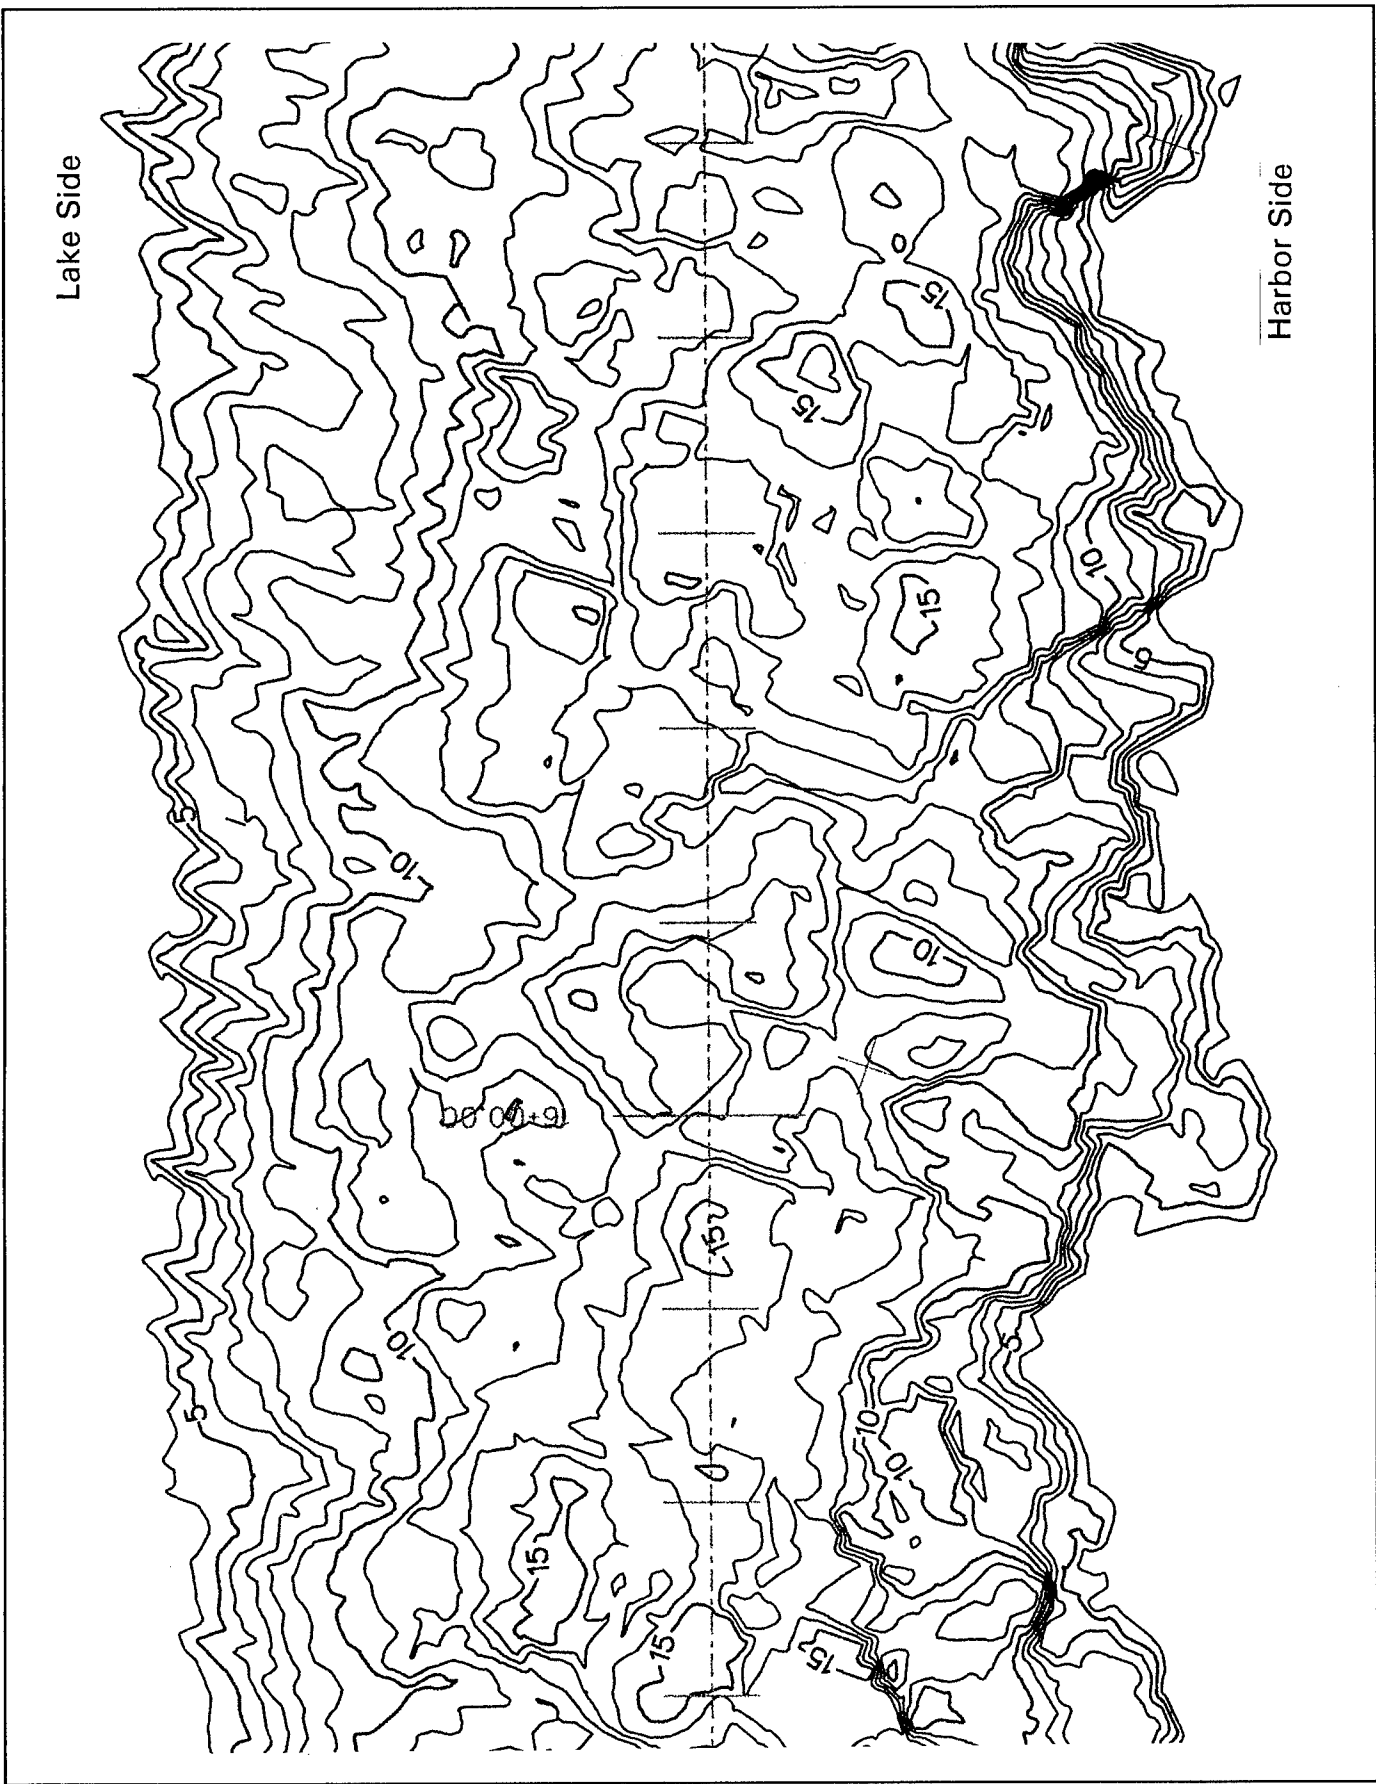
Figure A19. Topography of Burns Harbor North Breakwater, sta 15+45-16+33

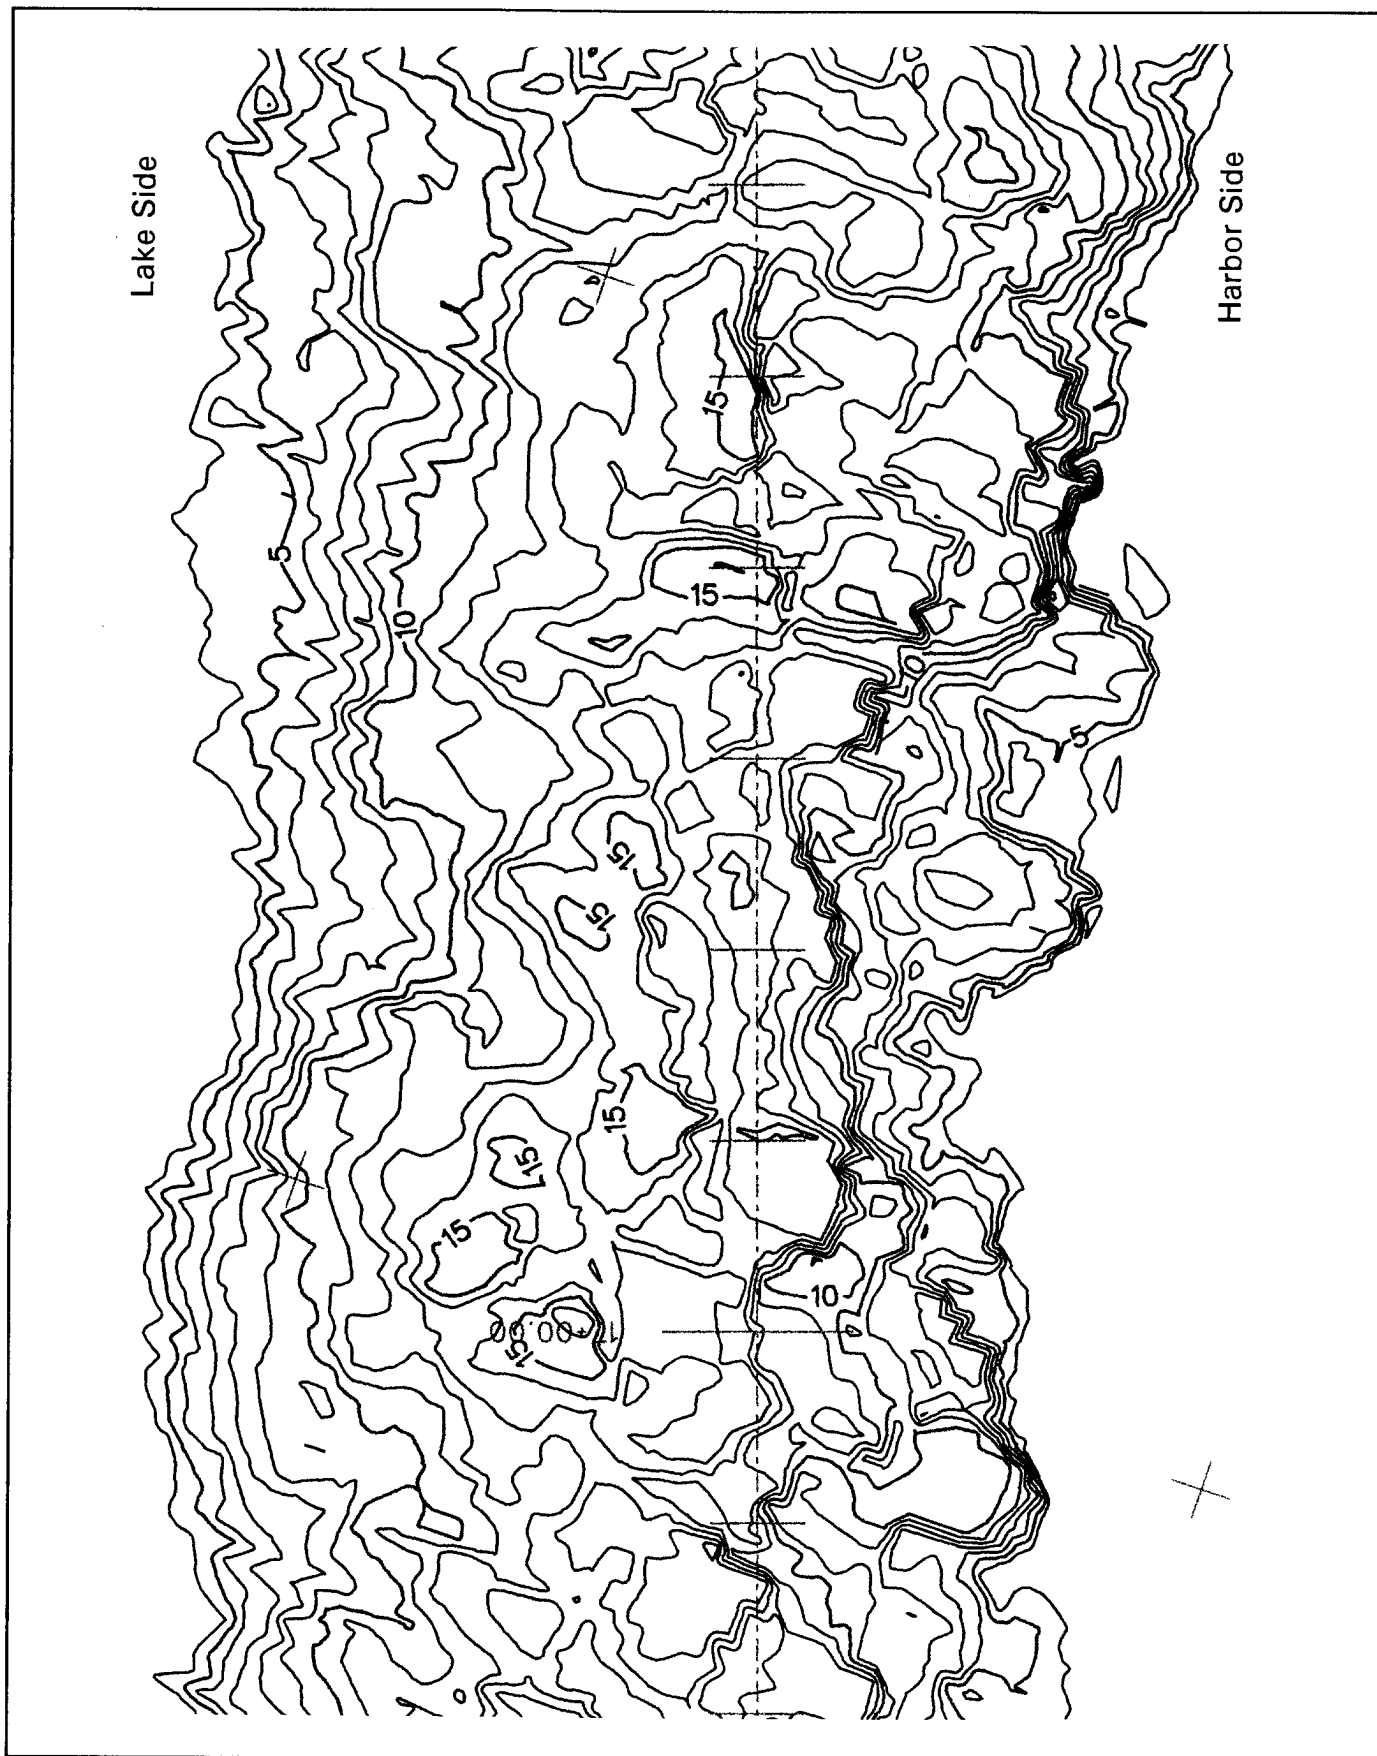
Figure A20. Topography of Burns Harbor North Breakwater, sta 16+33-17+20

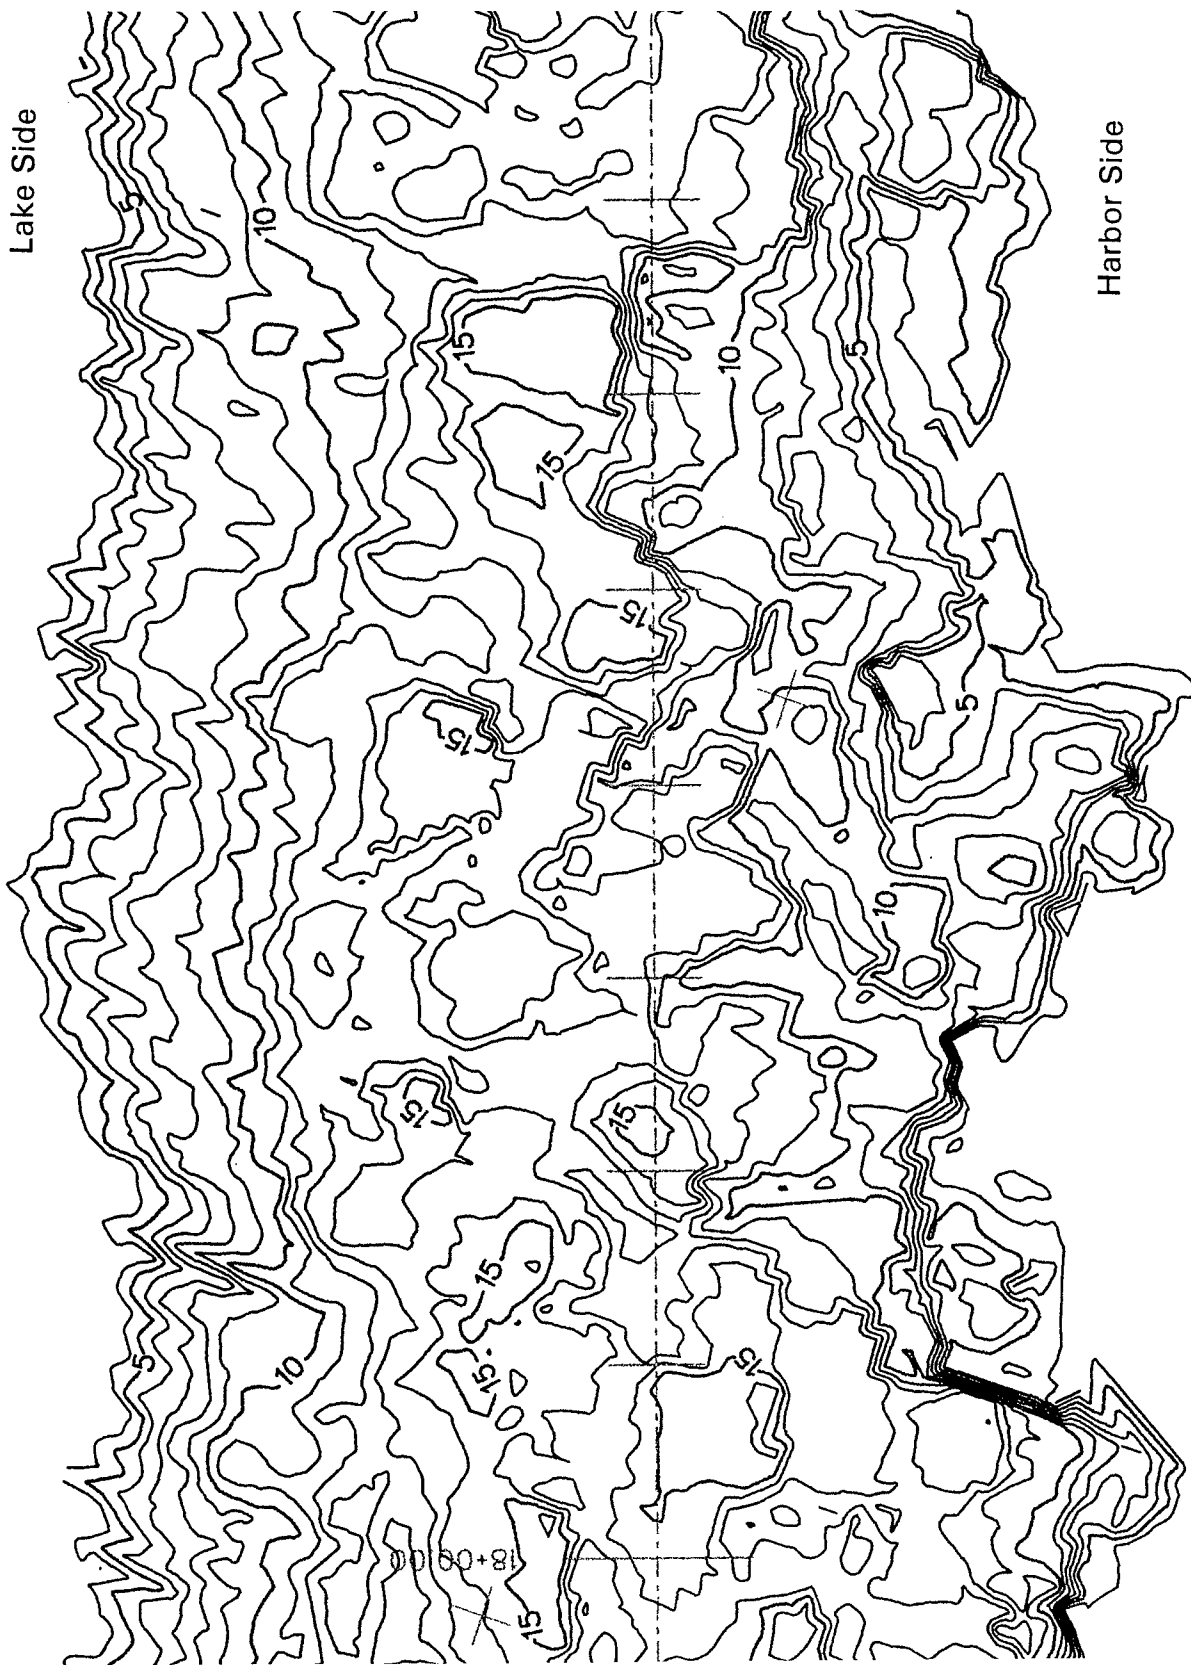
Figure A21. Topography of Burns Harbor North Breakwater, sta 17+20-18+05
